Navajo Abandoned Uranium Mine

Site Screen Report

NA-0904 AUM Site

August 2010

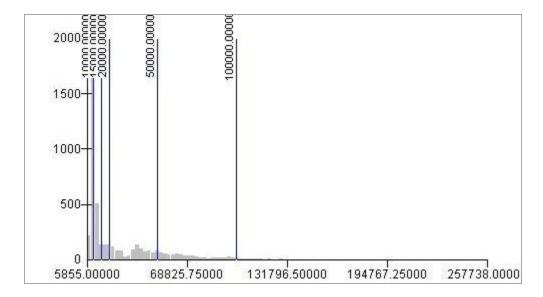
The following chart and statistics were generated by ESRI ArcGIS 9.3.1, and show the general distribution of the site gamma radiation measurements. The horizontal X axis represents the gamma radiation reading levels in cpm (lowest levels to the left). The vertical Y axis represents the frequency of each gamma radiation level.

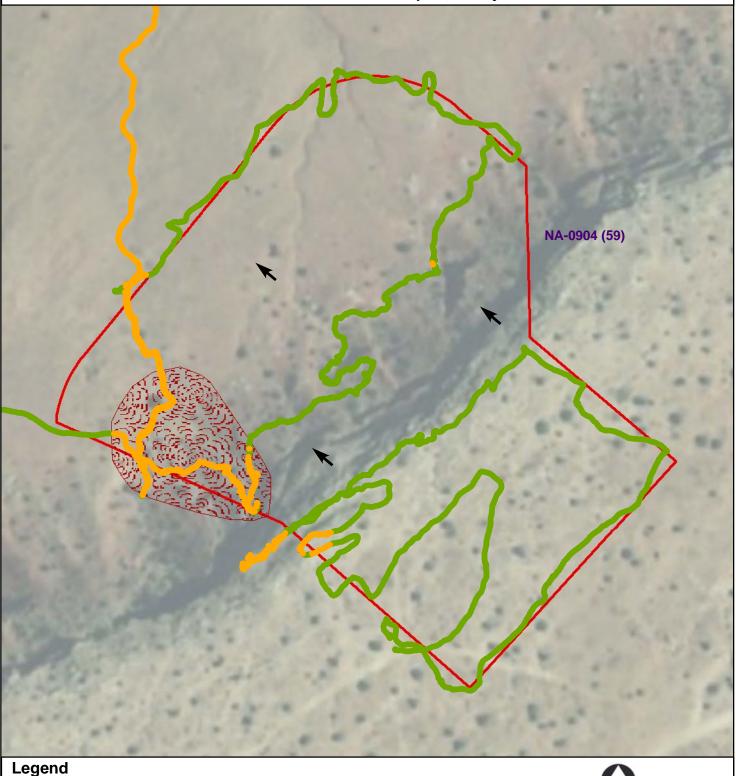
Figure 1 - Gamma Radiation Measurements, Above Two Times Background NA-0904 (59) **Sweetwater / Teec Nos Pos Chapter, Navajo Nation**

A total of 4,755 gamma radiation measurements were collected from the mine site, ranging from 5,855 cpm to 257,738 cpm. Measurements collected in the vicinity of the waste debris were found at levels up to approximately 250,000 cpm, and along the haul road ranging from approximately 30,000 cpm to 200,000 cpm. The measurements are represented in Figures 1 and 2

Observed Waste Pile
